Debris/Ice/TPS Assessment and Integrated Photographic Analysis of Shuttle Mission STS-79

**DEBRIS/ICE/TPS ASSESSMENT
AND
INTEGRATED PHOTOGRAPHIC ANALYSIS
OF
SHUTTLE MISSION STS-79**

16 September 1996

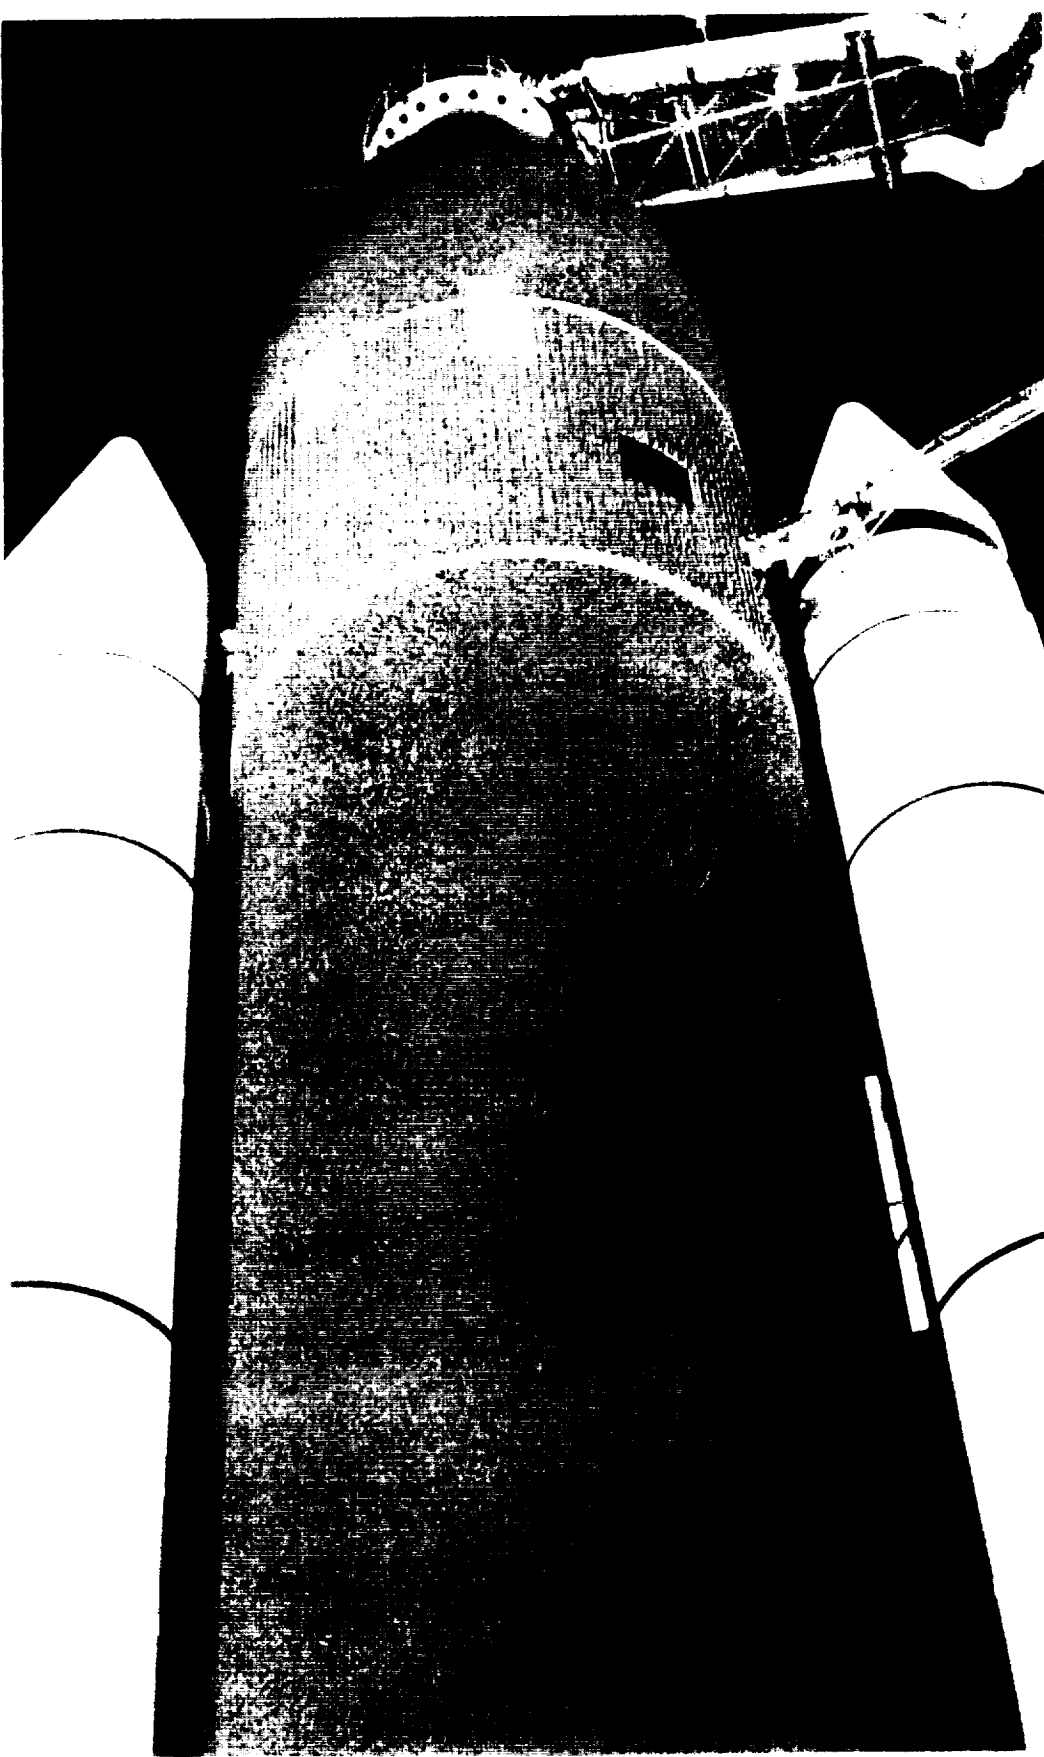
Photo 4: ET Cryoloaded for Launch

There were no LH2 tank TPS acreage anomalies. Light condensate, but no ice or frost accumulation, was present on the acreage. TPS surface temperatures ranged from 77-79 deg. F. ET-82 was the first flight that utilized the new composite Intertank door.

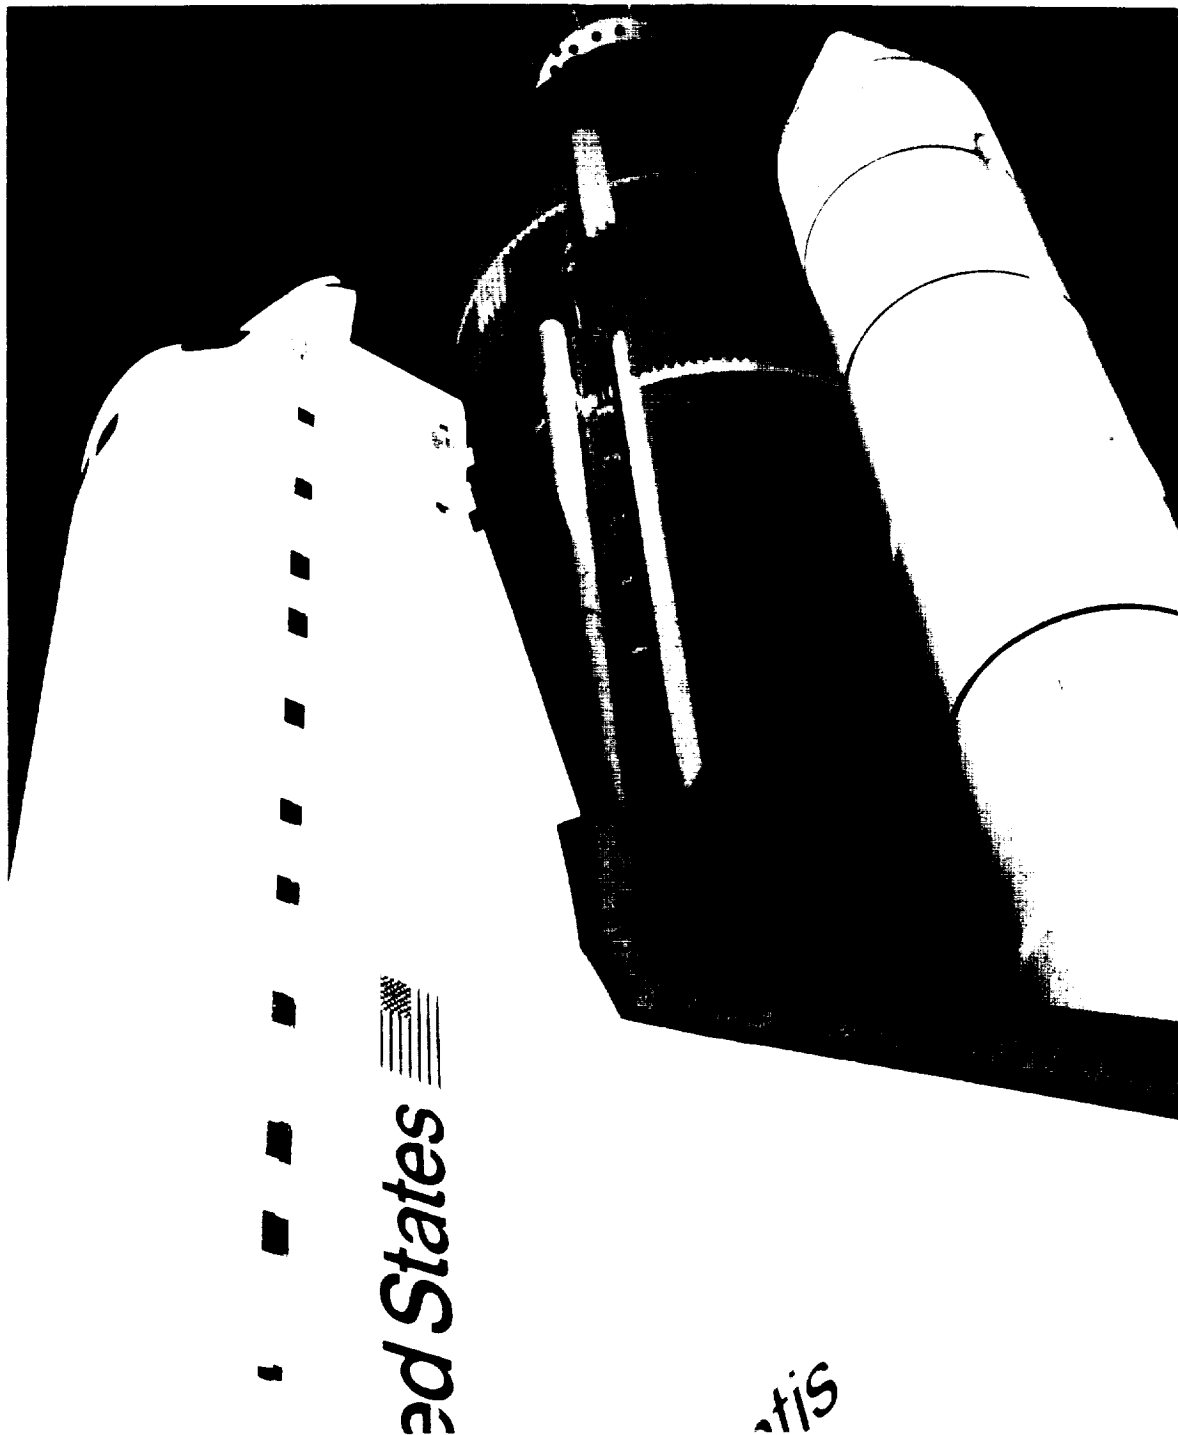
Photo 5: STS-79 Cryoloaded for Launch
OV-104 Atlantis (20th Flight), ET-82 (LWT 75), and BI-083 SRB's

There were no LH2 tank TPS acreage anomalies. Light condensate, but no ice or frost accumulation, was present on the acreage. TPS surface temperatures ranged from 77-79 degrees F. There were no anomalies on the new method bipod jack pad standoff closeouts. A crack, 3-inches long by 1/4-inch wide, was present in the -Y vertical strut attachment fitting fairing forward surface TPS. The presence of the crack was acceptable for flight per NSTS-08303 criteria.

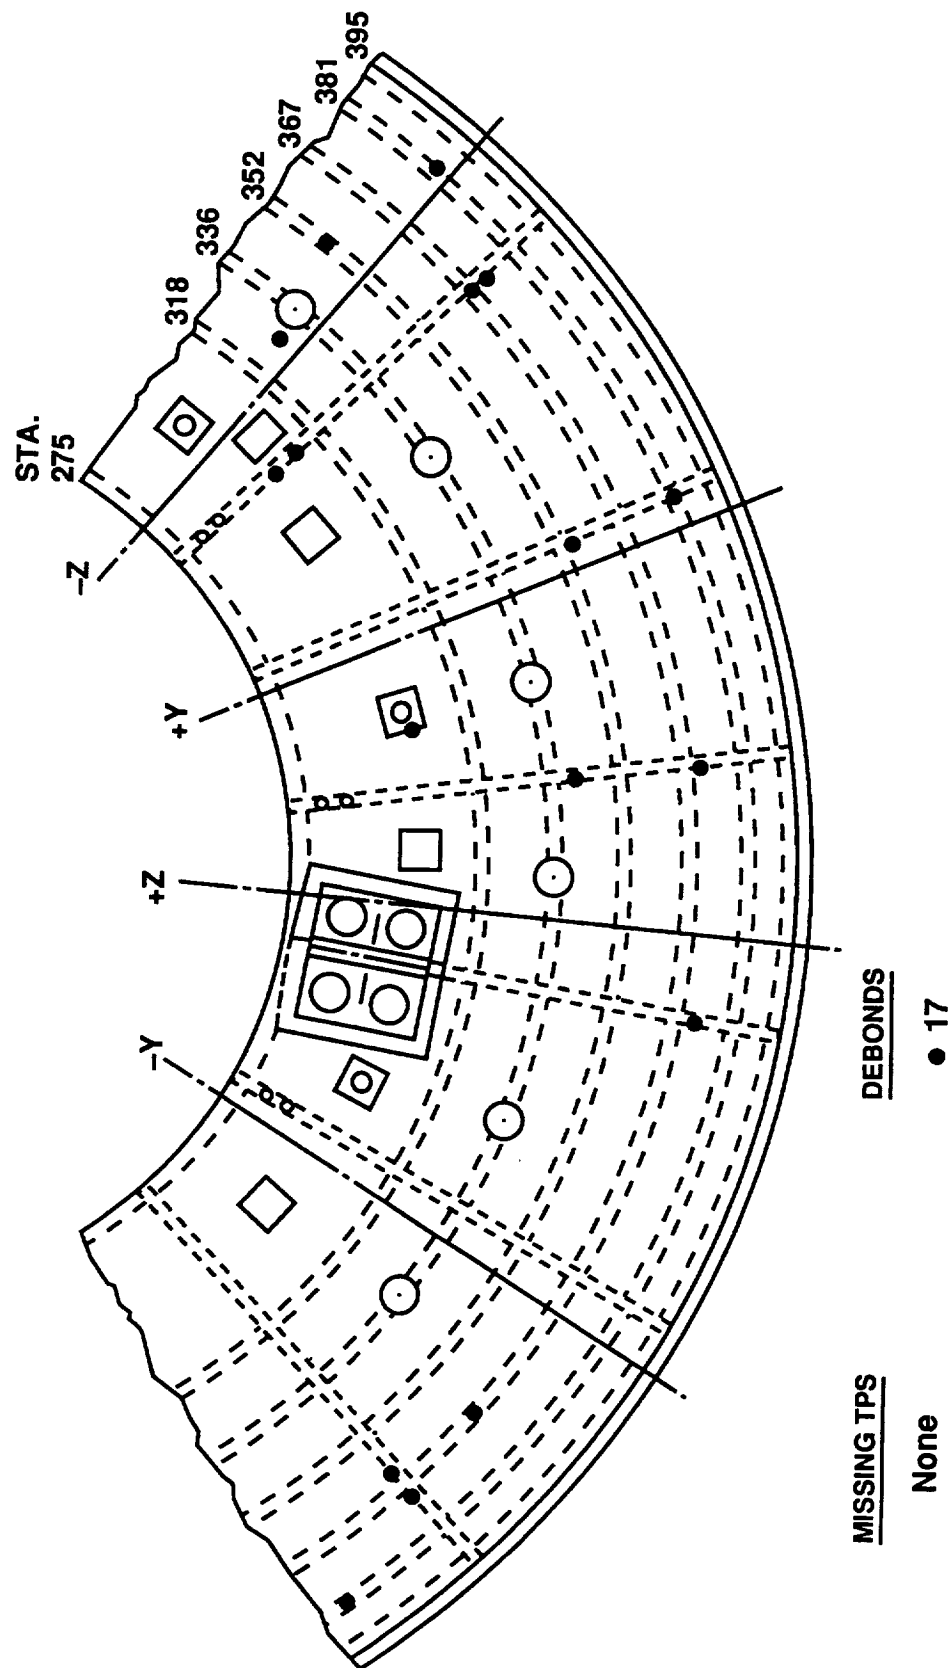
Figure 1: RH SRB Frustum

The RH frustum was missing no TPS. The number of debonds over fasteners (17) was less than average (Figure 1). Hypalon paint was blistered/missing along the XB-395 ring frame where BTA closeouts had been applied. However, most of the exposed BTA substrate was not sooted. The BSM aero heat shield covers had locked in the fully opened position.

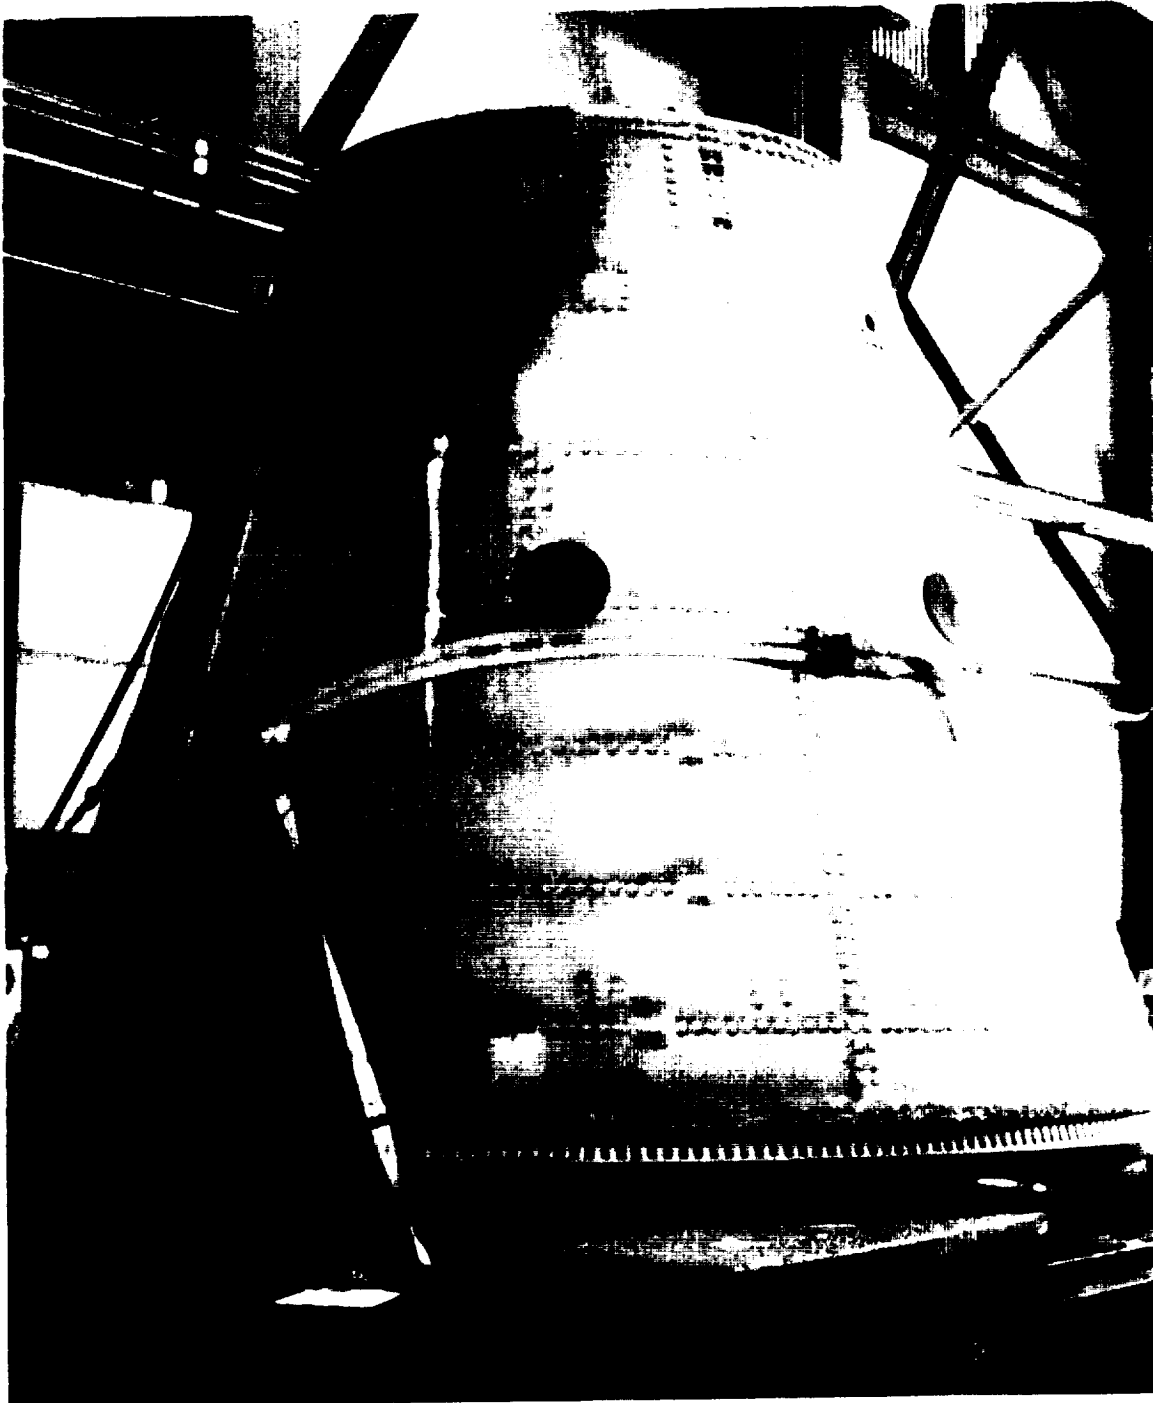
Photo 11: RH Frustum

The RH frustum was missing no TPS. The number of debonds over fasteners (17) was less than average. Hypalon paint was blistered/missing along the XB-395 ring frame where BTA closeouts had been applied. However, most of the exposed BTA substrate was not sooted. The BSM aero heat shield covers had locked in the fully opened position.

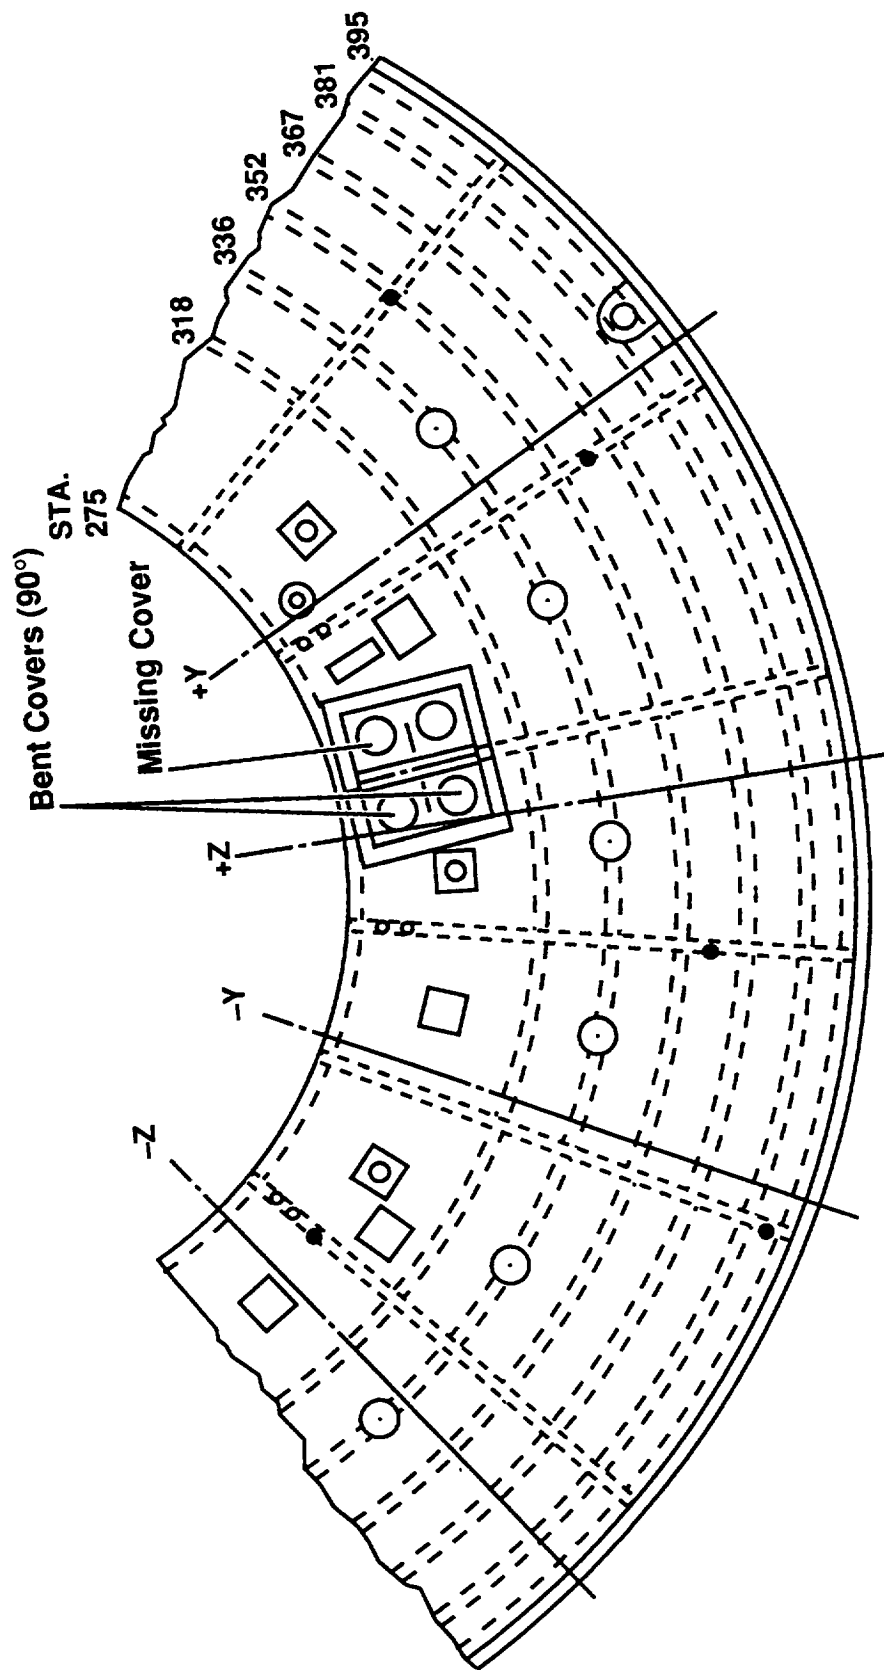
Figure 2: LH SRB Frustum

The LH frustum was missing no TPS. The number of MSA-2 debonds over fasteners (5) was less than average (Figure 2). Hypalon paint was blistered/missing along the XB-395 ring frame where BTA closeouts had been applied. However, most of the exposed BTA substrate was not sooted. The two left BSM aero heat shield covers had been bent by parachute entanglement; the lower right cover was locked in the fully open position, and the forward right cover was missing.

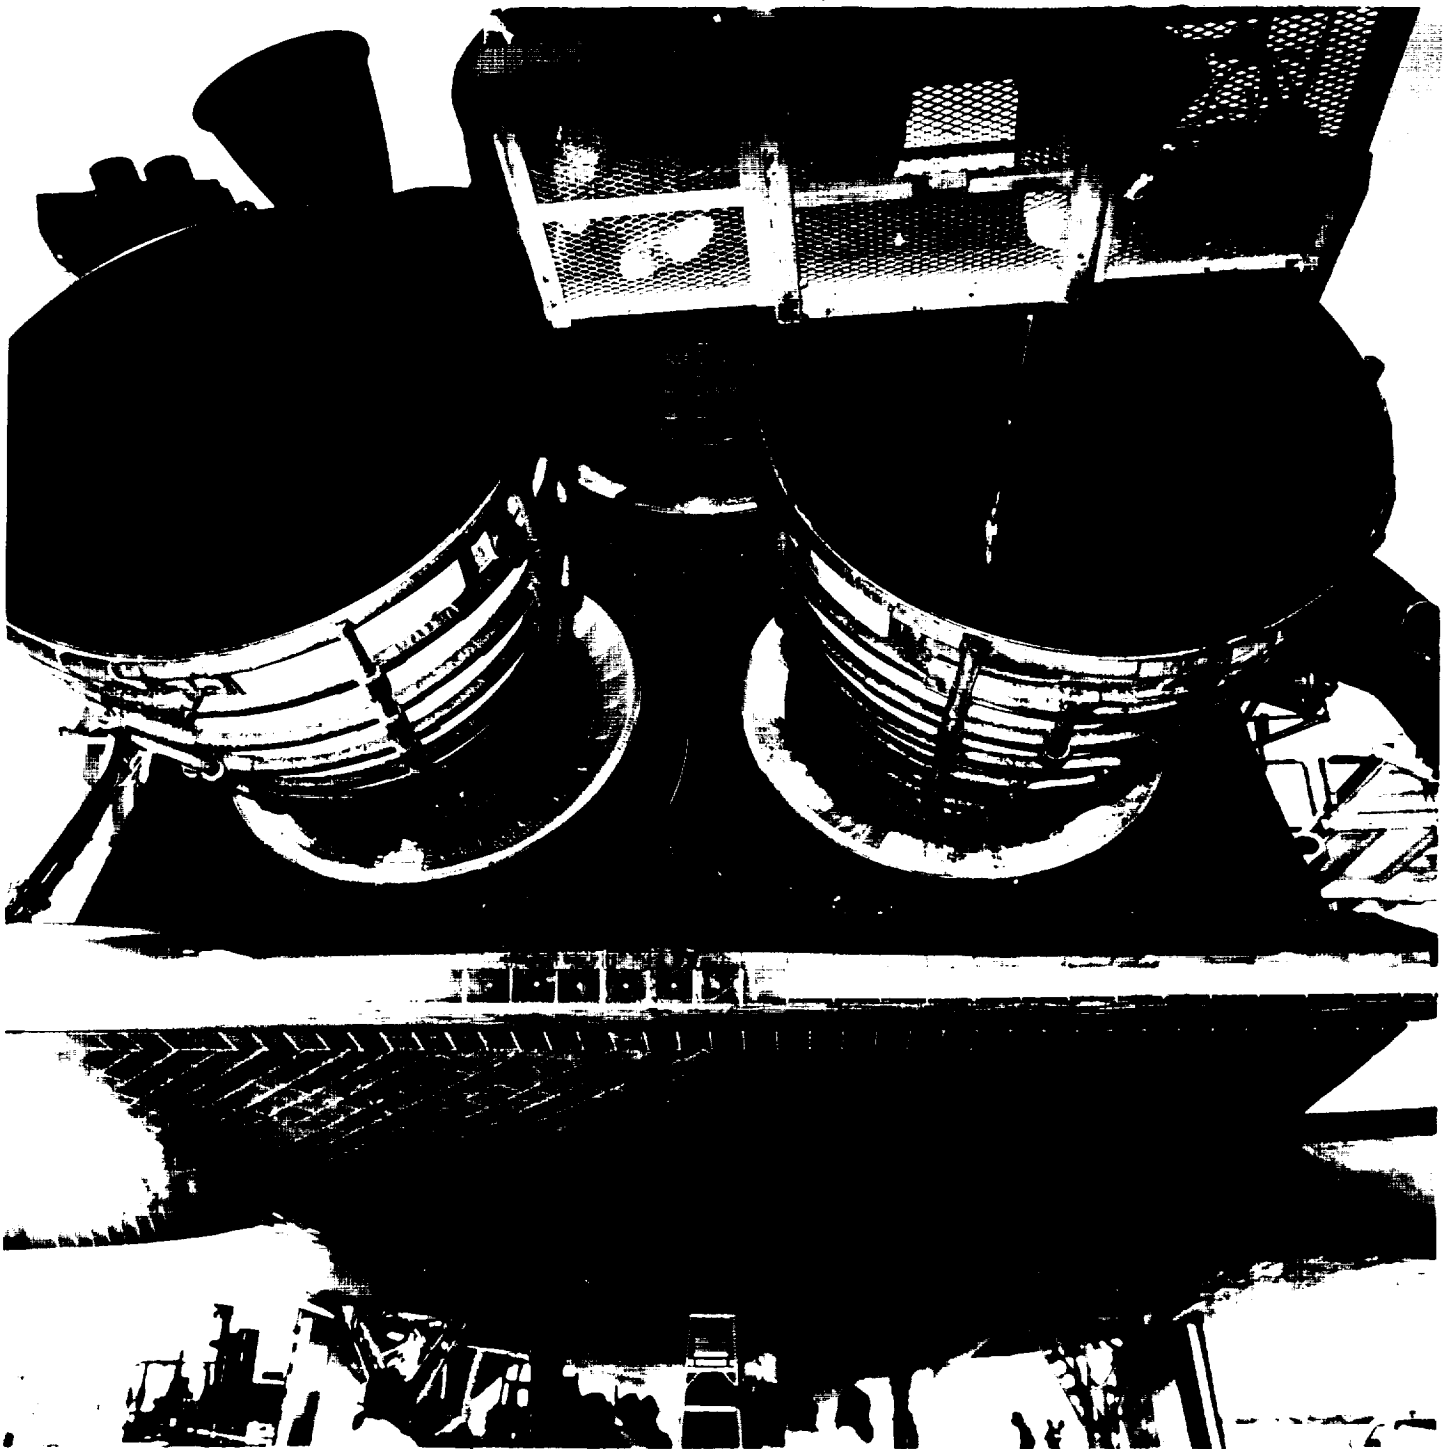
Photo 22: Base Heat Shield/SSME's

All three SSME Dome Mounted Heat Shield (DMHS) Blankets were in excellent condition.

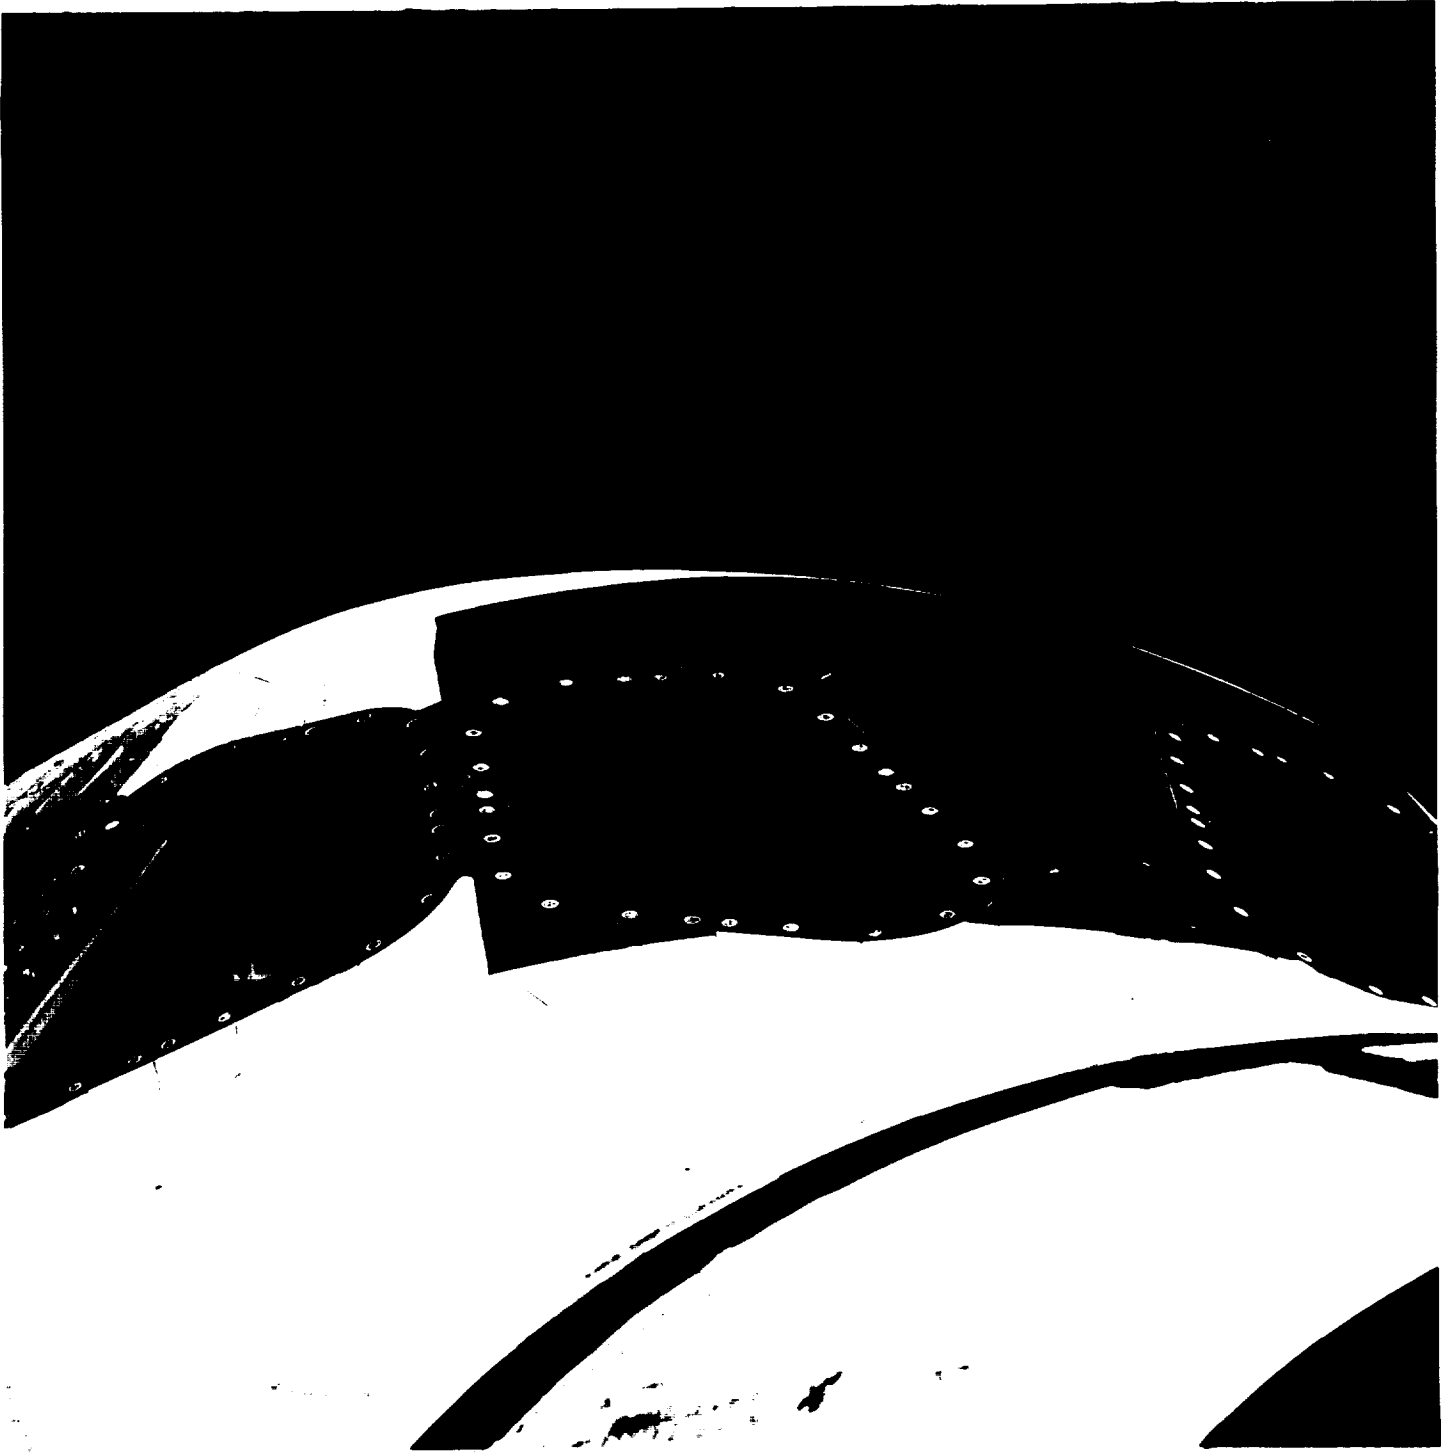
Photo 25: Orbiter Windows 4-6

Hazing and streaking of Orbiter windows #4 and #5 was typical. Window #4 had 2 splatter marks which were most likely caused by impacts from FRCS RTV.

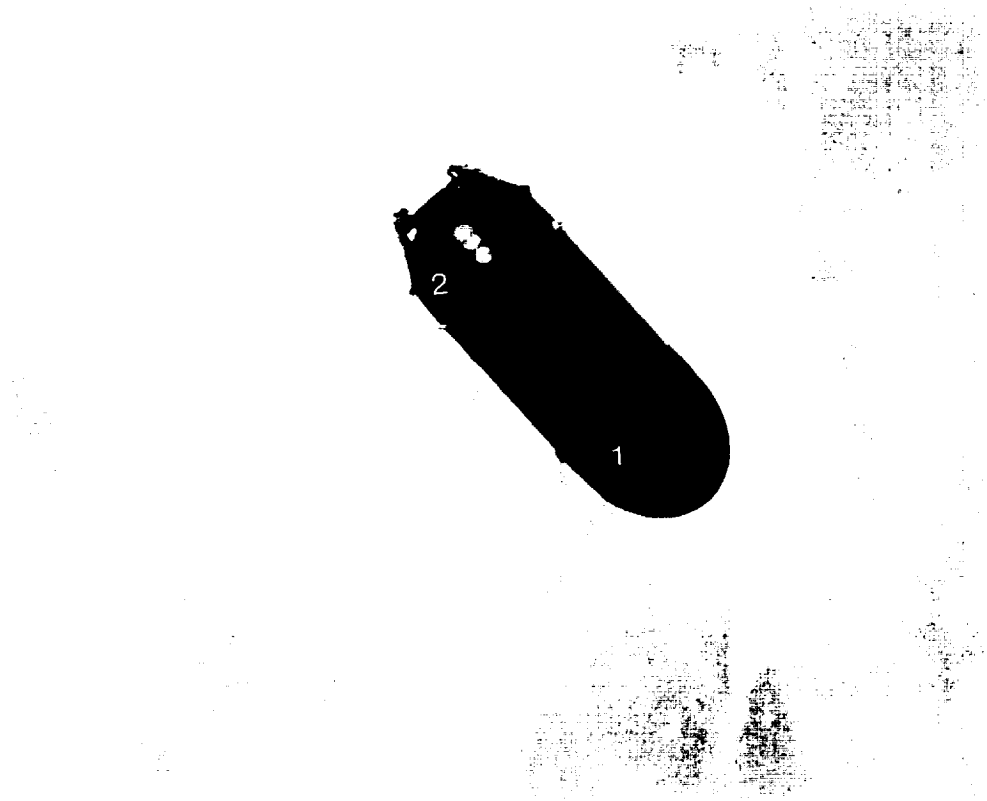
Figure 2.4.2 (A) Handheld View of the External Tank

STS-79 was the first flight of the dark composite intertnk access door (which replaces the previously used foam-covered door). The new composite intertank access door appears in good condition in the handheld camera view above (1).

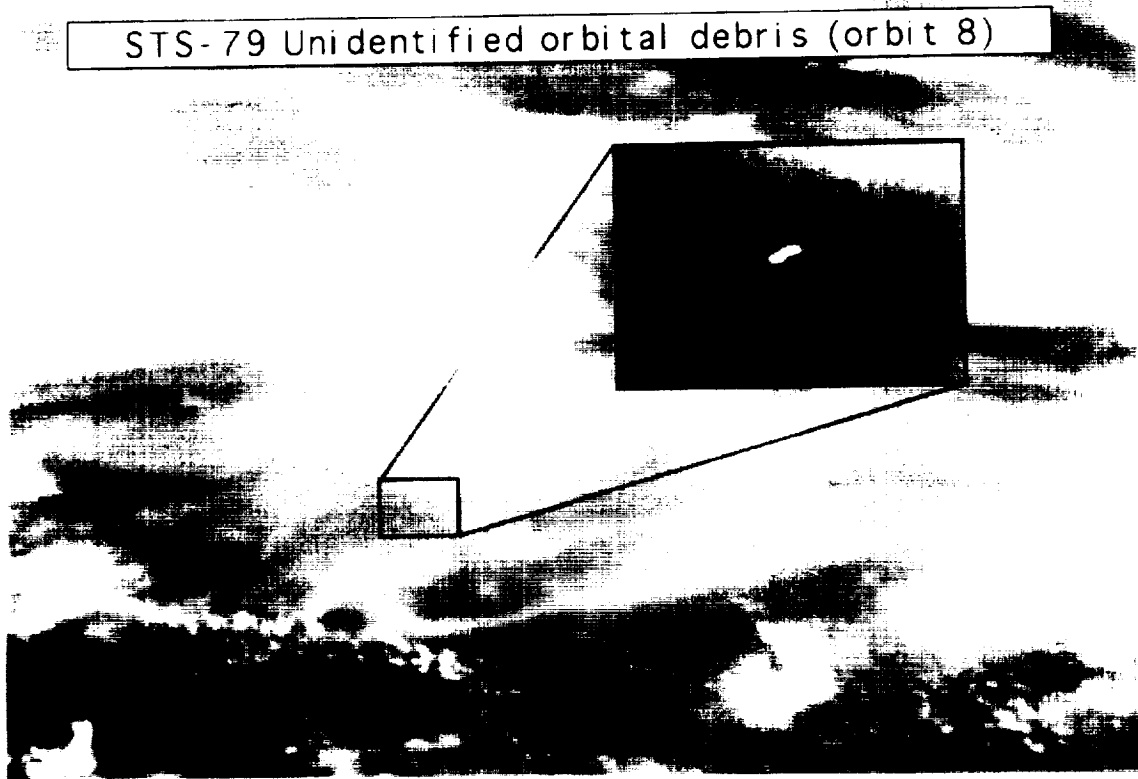
Figure 2.5.1 Debris Seen on Orbit 8

Analysis of a five minute segment of STS-79 downlink taken 11 hours after launch (260:19:58 UTC), revealed a bright-colored piece of debris moving in proximity to the Orbiter at a lower altitude and a slightly different inclination. The debris appeared uniformly white in color, oblong in shape ($L/D = 3$), and was gyrating freely with a period of approximately 0.7 seconds. Attempts to determine the size of the debris were inconclusive.
